Vaisala Precision Lightning Warning System (PLWS)

Hillsborough County Aviation Authority acted on behalf of the Tampa Airport Managers Association (TAMA) to contract with Global Atmospheric (now having been acquired and known as **Vaisala, Inc.**) for installation of the Precision Lightning Warning System (PLWS) in June, 1996 for a sum of \$176,537.37. We have recurring monthly payments to Vaisala for the full maintenance responsibility of the installed equipment for \$2,045.10 and satellite operational data services for \$332.92. The attached handout diagrams the components which make up this system with Remote Alarm Display Systems (RADS) installed typically in the Operations Offices of the participating airlines. The system operates from three sources of data: national satellite lightning strike data and two electronic field mill sensors, which measure voltage potential. The advantage of the Vaisala system is the ability to predict when a lightning strike may occur, with multiple sensor sources, vice others, which only alarm after the fact.

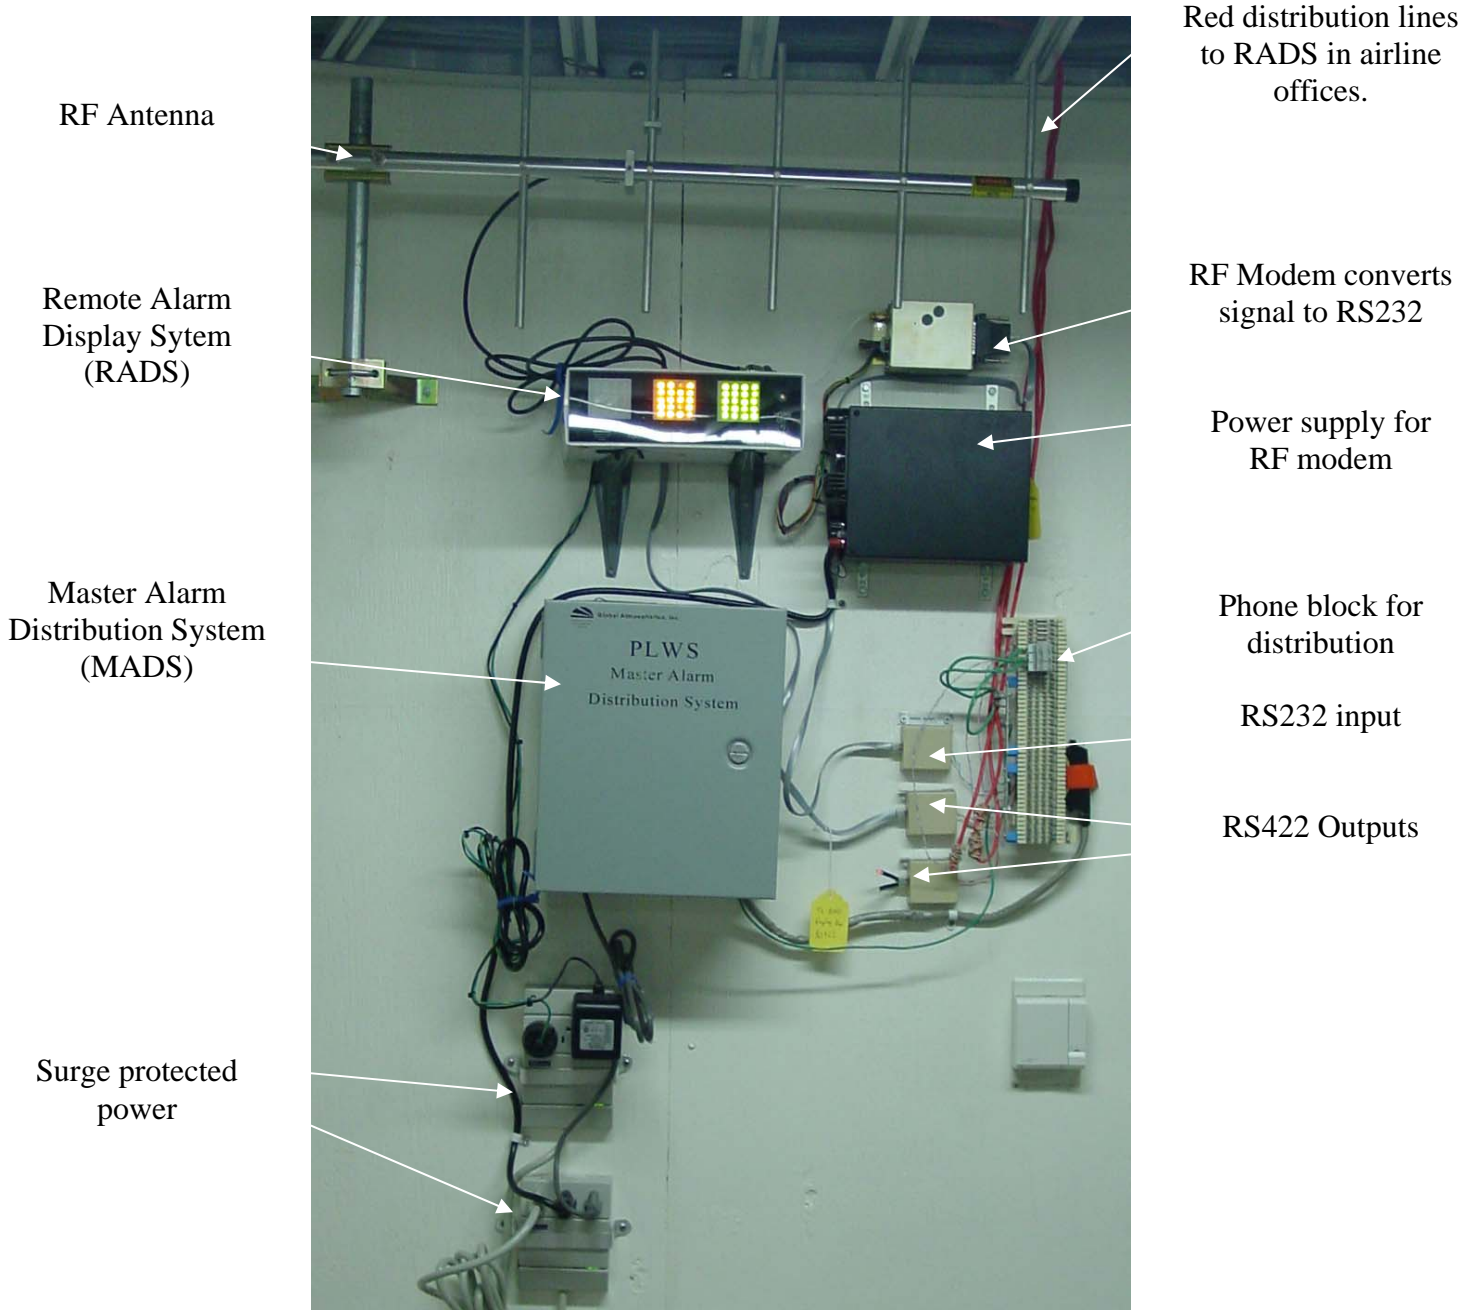
Precision Lightning Warning System (PLWS)
 Master Alarm Distribution System (MADS)
 Installation at Airside "E" (typical)

Sequence of operation: Equipment is mounted on bulkhead of Main Comm. Room. RF antenna receives the PLWS signal from the CY Core penthouse transmitter. Signal is converted by RF Modem to RS232 input to phone block and Master Alarm Distribution System (MADS). Data is processed and sent to RADS in various airline spaces via CAT5 cabling.

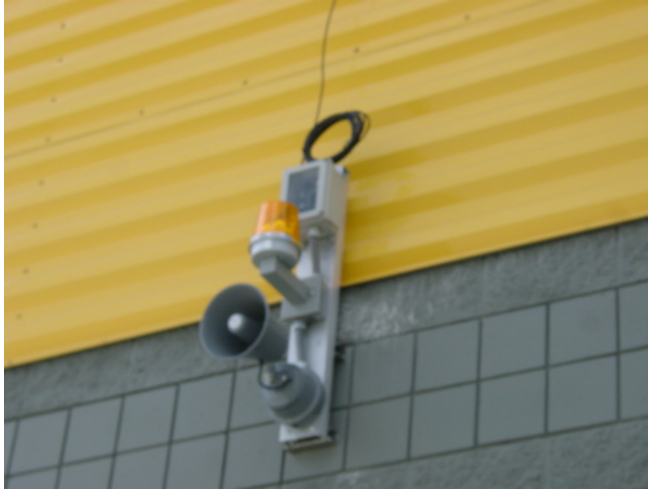
Exterior Remote Enunciator unit

Each RE unit has a receiver box with antenna, horn, and beacon. When a “red” RADS danger condition exists, the yellow RE beacon will begin flashing and the horn will emit 5 to 6 blasts. The yellow beacon will continue to flash as long as the “red” RADS danger condition exists. When the danger has passed, the PLWS system will improve to any lesser indicated threat level, after a 5-minute delay. The beacon will then stop flashing and a 14-second siren will sound the “all clear”. If alarm parameters are again reached, the system will alarm again.

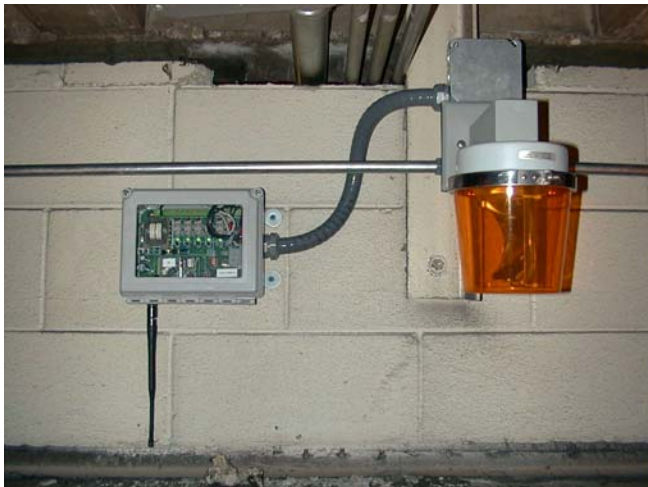
Interior Bag Makeup Area RE

The Bag Makeup and Sort Areas for Airsides A, C, E and F have yellow beacons installed above the tug exists, but no horns. The yellow beacon flashes the same as the RE unit at the Airsides.

Conveyor construction in the Landside Terminal Bag Makeup Area has degraded the signal activating these units and will be inoperable until completion of work in progress to modify the system from a RF radio signal to cable.
